March 12, 2007  
Project DRF070312

**Re:** Initial comments on the North Alouette River flooding on March 11 and 12, 2007 that damaged your nursery and other facilities.

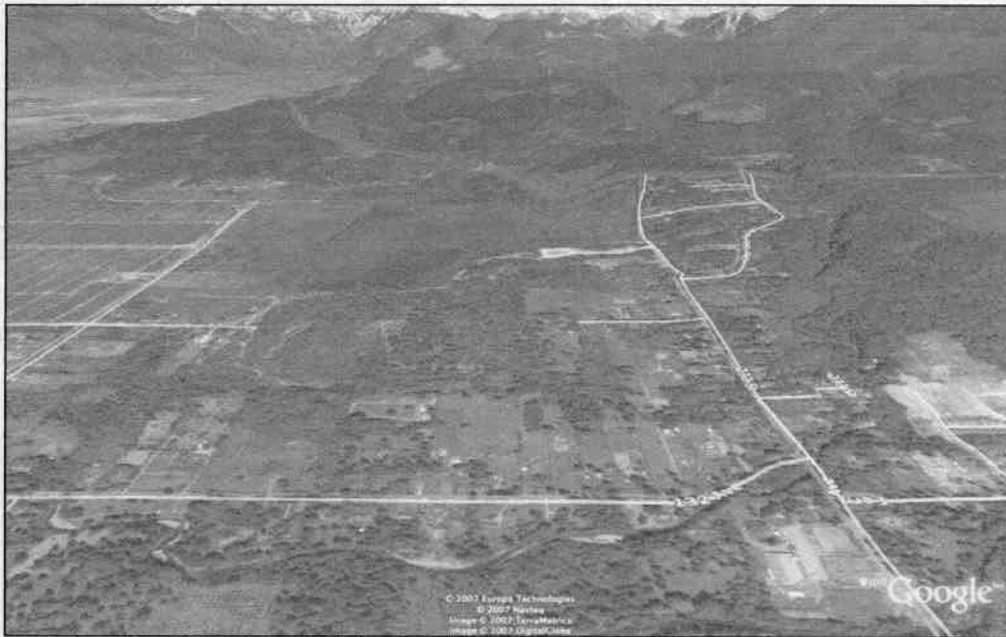
**Figure 1:** Looking north over the area in Maple Ridge affected by flooding, showing the approximate path of the water that flowed out of the North Alouette River starting at a private bridge on the east side of 232<sup>nd</sup> Street near 132<sup>nd</sup> Avenue, and then west in a new channel north of and approximately parallel to 132<sup>nd</sup> Avenue in Maple Ridge, B.C.

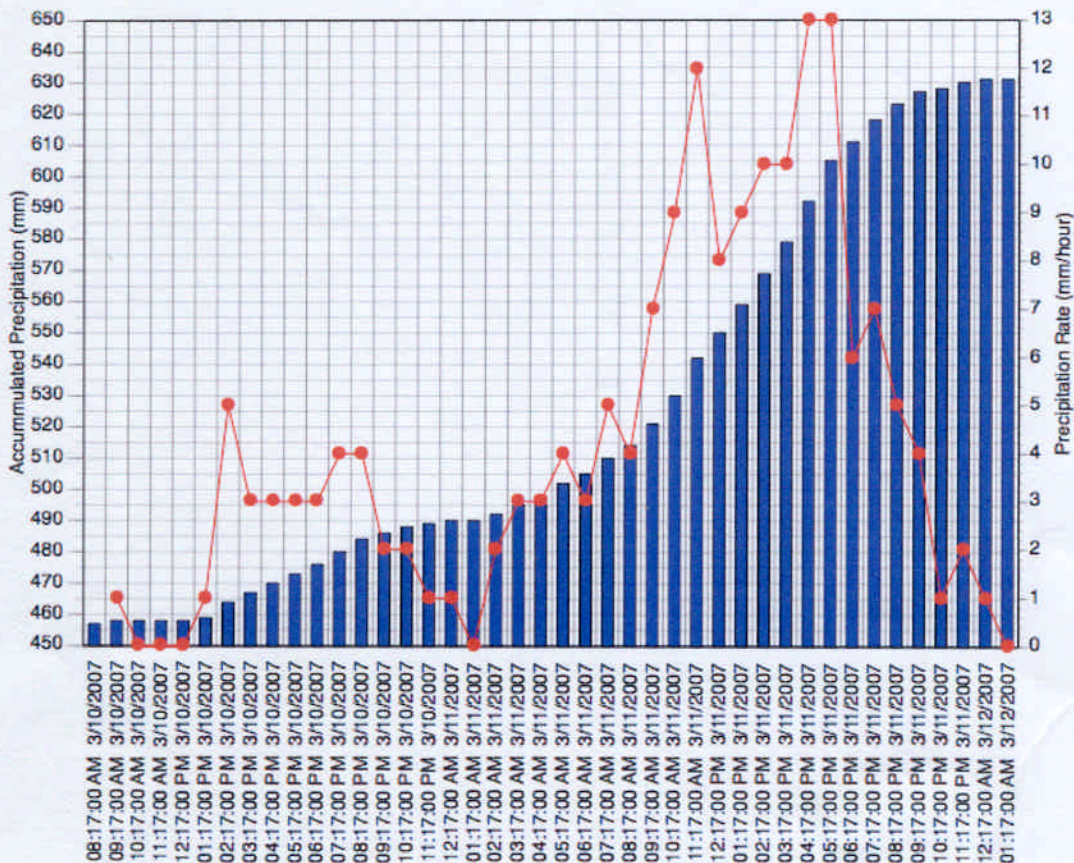
**Figure 2:** Precipitation data from the B.C. Hydro Hydromet station (ALU) at Alouette Dam, about 8.5 km northeast of the area of flooding. The red line shows the rate of precipitation.

- Not only did a lot of rain (a total of 173 mm or almost 7 inches) fall over the 36 hours, but the intensity at times was very high at 13 mm (0.5 inch) per hour.
- During the storm, temperatures also rose from about 6.8°C to a high of about 12.9°C. This is significant because it caused freezing levels to rise to over 2000 metres, prompting a considerable amount of snow to melt, which would have added to the precipitation-induced runoff.

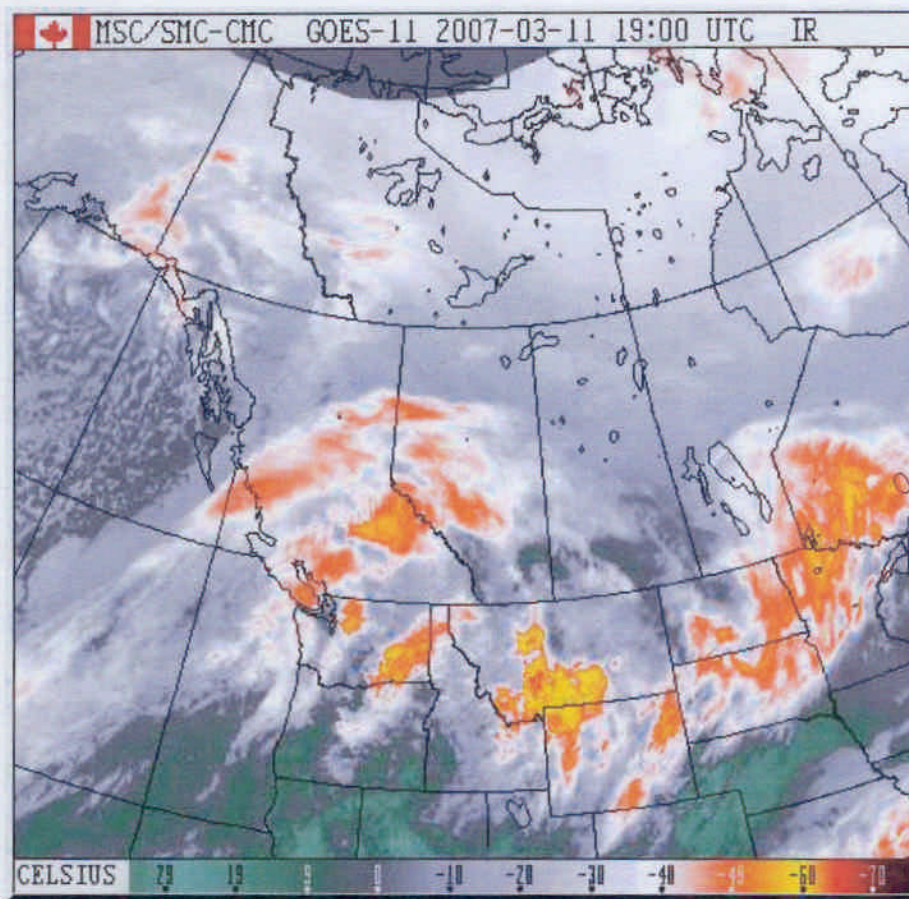
- The precipitation was brought in by a particularly intense southwesterly flow of relatively warm and moist air that originated in the Pacific Ocean near Hawaii; this is sometimes referred to as a "Pineapple Express" rainstorm.

**Figure 3:** Environment Canada satellite image taken during the height of the storm at about 12:00 pm (noon), Sunday, March 11, 2007.

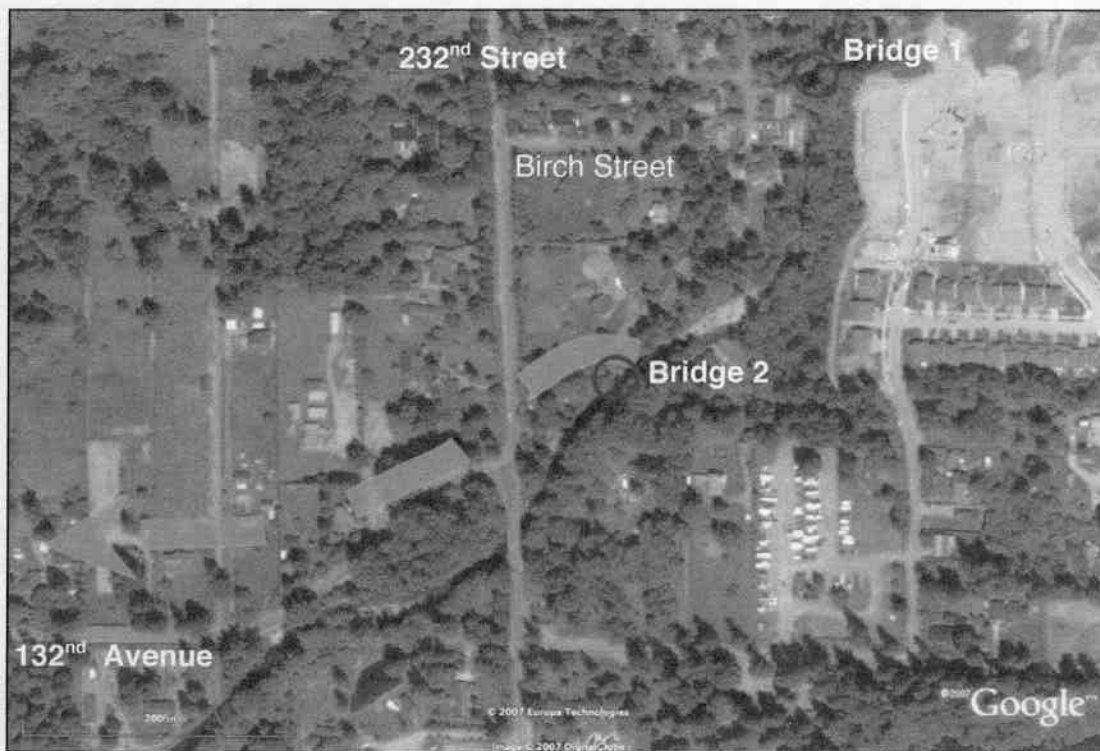
- A traverse of a portion of the lower North Alouette River and interviews with local residents suggests that the flooding was caused by high water flows that first caused bank erosion to occur about 450 metres upstream from the bridge across the North Alouette River near the intersection of 232<sup>nd</sup> Street and 132<sup>nd</sup> Avenue. This bank erosion caused several large trees and sediment to topple into the water.

6. Just east of the intersection of Birch Street and 233<sup>rd</sup> Street, at about N49.24571°, W122.57689° (NAD 83 datum), the water and debris carried by the North Alouette river piled up against an old log bridge and caused it to wash out. Based on the position of the remaining log crib abutments, the bridge had wood stringers that were about 18 metres long, and the bottom of the bridge (soffit) was located about 2.8 metres above the bottom of the river channel. Based on measurements of the channel at this point, the cross-sectional area under the bridge would have been about 48 square metres. However, two large concrete blocks from an earlier bridge are also present in the channel at this point, and would reduce the overall hydraulic capacity somewhat.

**Figure 4:** Aerial image of the area where flooding initiated, showing various features and the approximate path of flood waters- they continued for several hundred more metres to the west.

2. The water and debris moved downstream and could not pass under an old wooden bridge that constricts the channel east of the end of Birch Street. Old concrete blocks under this bridge added to the problem of reduced channel capacity and interfered with the passage of debris.

3. The old concrete abutments that partially block the North Alouette River channel east of Birch Street should be removed in order to increase hydraulic capacity and reduce the possibility of future blockages.

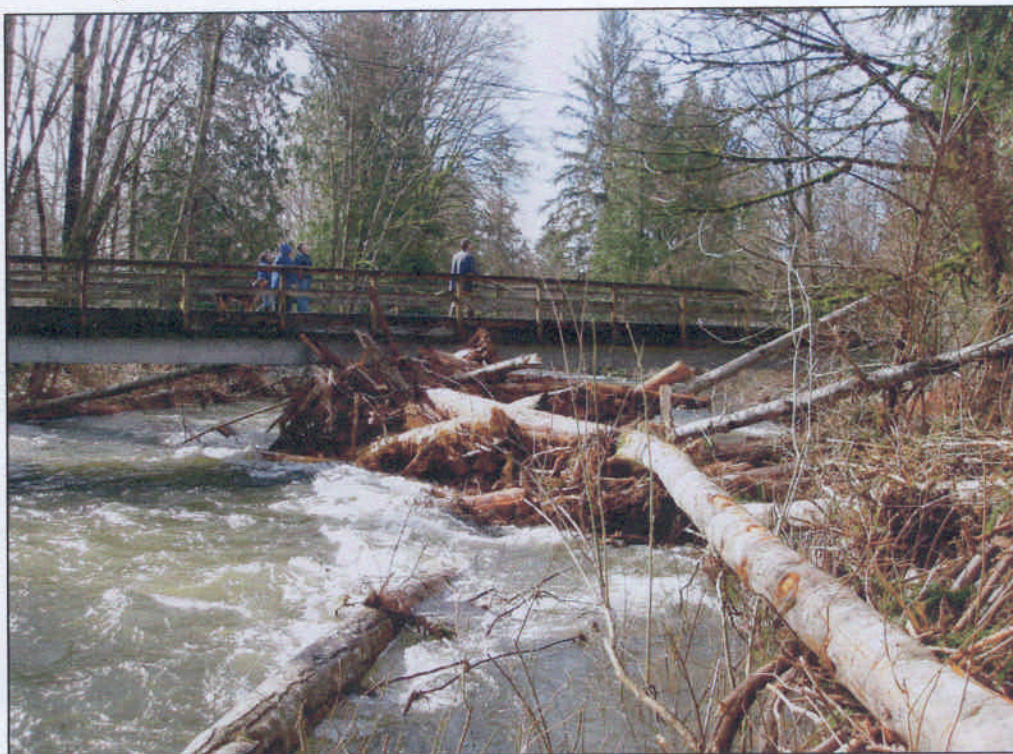
8. The floating mass of woody debris containing the remains of Bridge 1, plus some additional woody debris, were caught up against the center pier of Bridge 2 and blocked much of the river right side of the channel. This greatly reduced the hydraulic capacity of the structure, causing water to back up and flow over the banks upstream on both sides of the bridge.

**Figure 5:** Bridge 2 and the mass of woody debris pushing up against its upstream side.

3. Eventually, the water pushing up against the old wood bridge (Bridge 1) destroyed it, and allowed the woody debris to be carried downstream, where it was then caught up against the center pier of a second bridge (Bridge 2). This second blockage then caused water to back up and rise, and spill over the right bank, and from there, flow for hundreds of metres parallel to 132<sup>nd</sup> Street through homes, farm buildings, roads and yards where it did a considerable amount of damage before eventually flowing back into its natural channel.

2. Woody debris up against the private bridge about 100 metres upstream on the North Alouette River from the corner of 132<sup>nd</sup> Avenue and 232<sup>nd</sup> Street should be removed as soon as possible in order to re-establish adequate channel capacity and reduce the possibility of future flooding. The design and capacity of this bridge should be checked to ensure that it is adequately able to convey flood flows, as well as pass woody debris and sediment, and, if not, to determine what design modifications may be necessary to minimize downstream impacts during future floods.
